CAPITAL COMPONENT RESERVE FUND STUDY

Pleasant Pointe Property Owners Association, Inc.
Pleasant Pointe, Heathsville, Virginia 22473

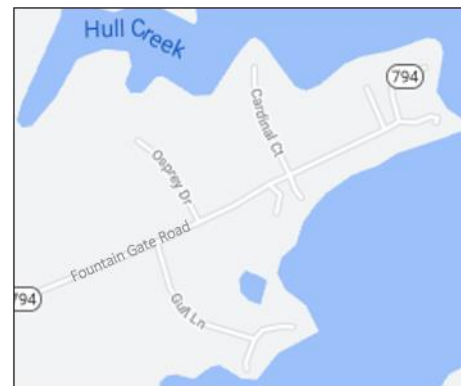
Figure 1: The Pleasant Pointe community comprises four roads: Fountain Gate Road, Gull Lane, Osprey Drive, and Cardinal Court.

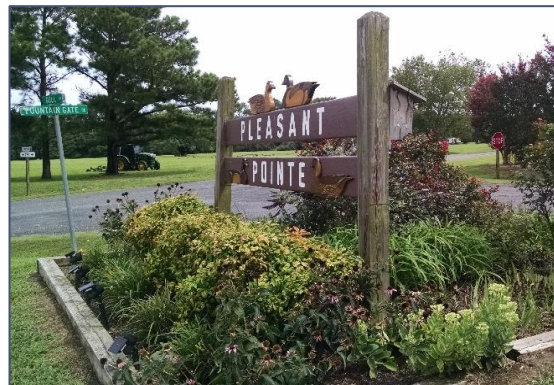
The entrance sign is constructed using two 6"x6"x10' wooden timbers affixed to two 2"x10' boards engraved with the Pleasant Pointe name. All boards are attached using stainless-steel bolts. Attached to the two boards are four carved, wooden ducks, which were painted by an artist who is related to a PPPOA board member.

Figure 2: A carved wooden sign bearing the Pleasant Pointe name is located at the corner of Fountain Gate Drive and Gull Lane.

The sign is repaired and maintained as needed, usually by a member of the PPPOA Grounds and Maintenance Committee. It was reinforced in 2018 using wood glue and concrete, and the stainless-steel bolts were replaced.

The current estimated cost to replace this sign is \$1,500.00.

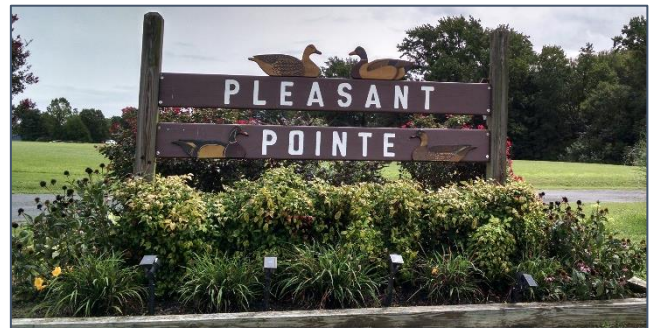
Figure 3: The flowerbed surrounding the Pleasant Pointe sign, above, is maintained annually or as needed by the PPPOA Grounds and Maintenance Committee.
